Feasibility Building Structures of PT. Suri Tani Pemuka Cirebon

Arief Firmanto

Faculty of Engineering, Gunungjati Swadaya University Cirebon

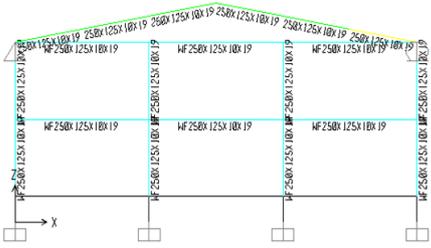
Check Struktur Gudang
7.

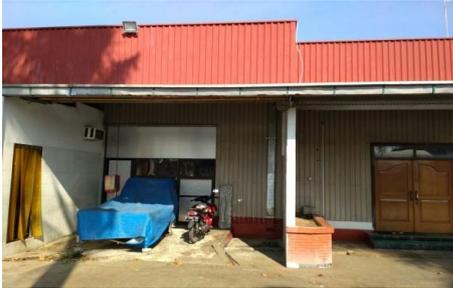
Plant Building 1
2

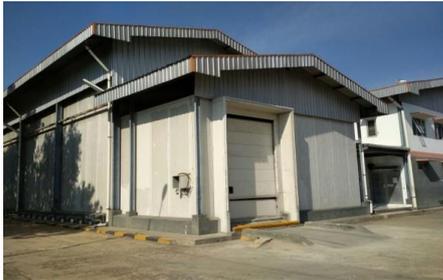
Plant Building 2
3

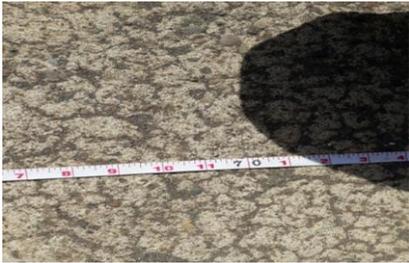
Measurement of Plant Building width 1
4
