Earthquake Risk Management for Mini-Hydro Power Plant: A Case Study Approach

This study evaluates the impact of an earthquake on a mini-hydropower plant (MHP) and formulates a disaster management strategy to enhance the operational resilience of MHPs against seismic events. Data was collected through interviews with relevant stakeholders, direct observations, and analysis of pertinent documents. The findings indicate that the 2018 Lombok earthquake caused severe damage to the catchment area, triggering increased sedimentation that disrupted the MHP's operation, resulting in decreased electricity production and escalated operational costs. Mitigation measures were implemented and proved effective in reducing debris-related downtime and improving electricity generation. These findings are expected to provide guidance for MHP operators in mitigating the negative impacts of earthquakes and similar disasters on plant operations.

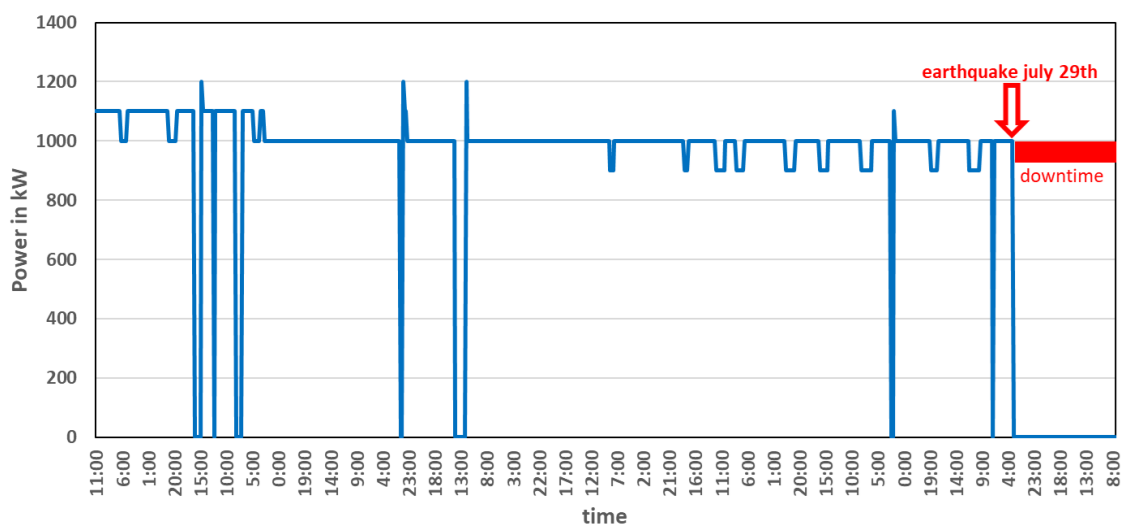
Figure 1. Power Production in July, 2018

Upon the occurrence of a seismic event, the mini-hydropower plant undergoes an automatic shutdown as precautionary measure. Due to the magnitude of the earthquake and the extent of the resulting damage, the system is subsequently subjected to a complete shutdown. The series of earthquakes that impacted Lombok Island in 2018 commenced on Juli 29th with a magnitude of 6.4, followed by a magnitude of 6.2 on August 5th, and culminated in two earthquakes occurring within a 10-hour interval on August 19th, registering magnitudes of 6.5 and 6.9, respectively.

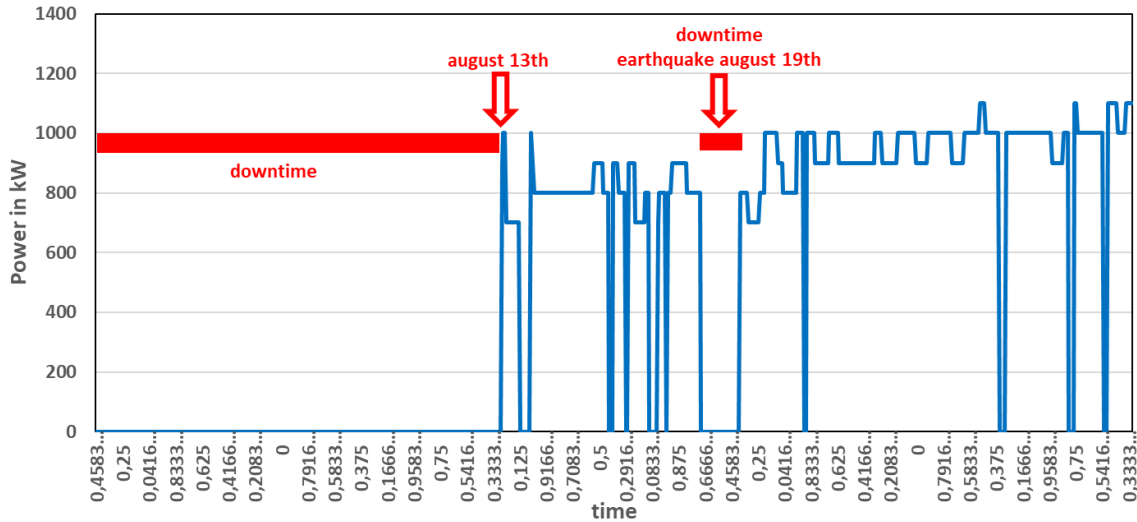
Figure 2. Power Production in August, 2018

the electricity distribution network infrastructure in the earthquake-affected area. The collapse of electricity poles, severance of distribution cables, and damage to electrical grid structures prompted the state electricity company (PLN) to halt the power supply, consequently leading to the shutdown of the power plant. Production records indicate that on July 29th, 2018, at approximately 8:00 AM local time, the generating unit underwent an emergency shutdown due to the earthquake and remained inoperative. The power plant was subsequently brought back to online on August 13th, 2018, at 2:00 PM (Figure 2).

Figure 2 also illustrates that, following the resumption of operations, the system continued to experience frequent disruptions, necessitating the shutdown of the power plant. These disruptions stemmed from disturbances within the electrical grid, primarily attributed to cable repairs, pole replacements, pole collapses, fallen trees, and other consequential events in the aftermath of the earthquake. In the instance of the seismic event on August 19th, the power plant was deactivated and rendered inoperative for a duration of 28 hours.

At the onset of the earthquake, the hydropower plant was operating at a capacity of 1 MW. However, the seismic event forced a cessation of operations for a period of 366 hours. This resulted in production loss of 366 MWh. A subsequent aftershock on August 19th further disrupted plant operations, leading to a 28-hour downtime and an additional production loss of 28 MWh. Moreover, disruptions to the electricity grid during August caused an additional 33 hours of operational downtime, contributing to a further production loss of 33 MWh. In total, cumulative production losses attributed to the earthquake and grid disturbances throughout August reached 426 MWh.

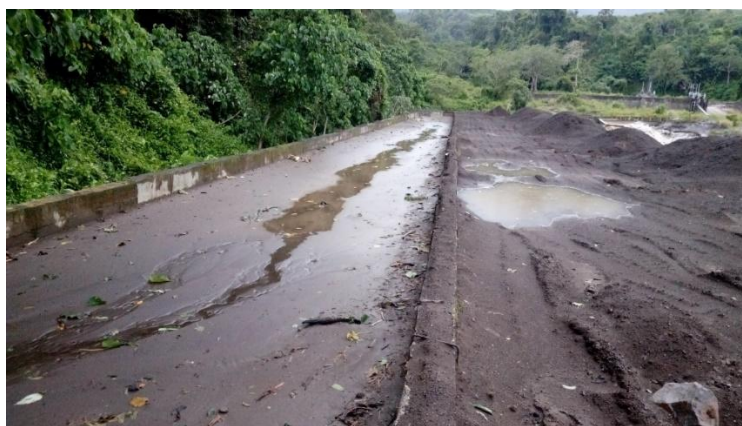
Figure 3. Image of the Channel During the Rainy Season (Documentation, January 23, 2019)

This disruption not only elevates the risk of sediment accumulation in the channel (Figure 3) but also leads to blockage of the hydropower plant intake by rocks and debris carried by the water flow. This accumulation of sediment and intake blockage directly contributes to increased operational downtime, necessitating more intensive and frequent maintenance to ensure the smooth flow of water and the continued operation of power plants.

This situation necessitates continuous channel clearing to ensure unimpeded water flow to the turbines. Consequently, this alters the operators' work patterns, requiring them to conduct more frequent patrols and channel cleaning. Furthermore, the utilization of excavators to remove blockage materials adds to the operational costs of the hydropower plant. These increases in operational costs and shifts in operator work patterns represent consequences of the earthquake's impact that must be borne by the plant.

A significant sedimentation phenomenon occurred within the hydropower plant's catchment area following the earthquake. This phenomenon commenced in November and December 2018, with a relatively low intensity. The intensity of sedimentation then escalated substantially from January to March 2019, before beginning to subside in early April 2019. This surge in sedimentation intensity is closely correlated with the rainy season in the region. High precipitation within the catchment area carries materials such as sediment, rocks, and logging debris into the rivers and streams leading to the hydropower plant. These materials subsequently accumulate in the channels and intake, leading to channel overflowing and blockage of the intake, ultimately preventing water from reaching the plant's turbine system.

To address the production decline caused by frequent downtime resulting from intake blockage and sediment accumulation in the water channels, the following mitigation measures were implemented: constructing an additional

intake as an alternative when the existing intake is blocked; increasing the number of excavators to expedite sediment removal from the channels; and constructing a second channel from the new intake to the settling basin, parallel to the existing channel, as an additional solution to mitigate downtime caused by sediment accumulation.

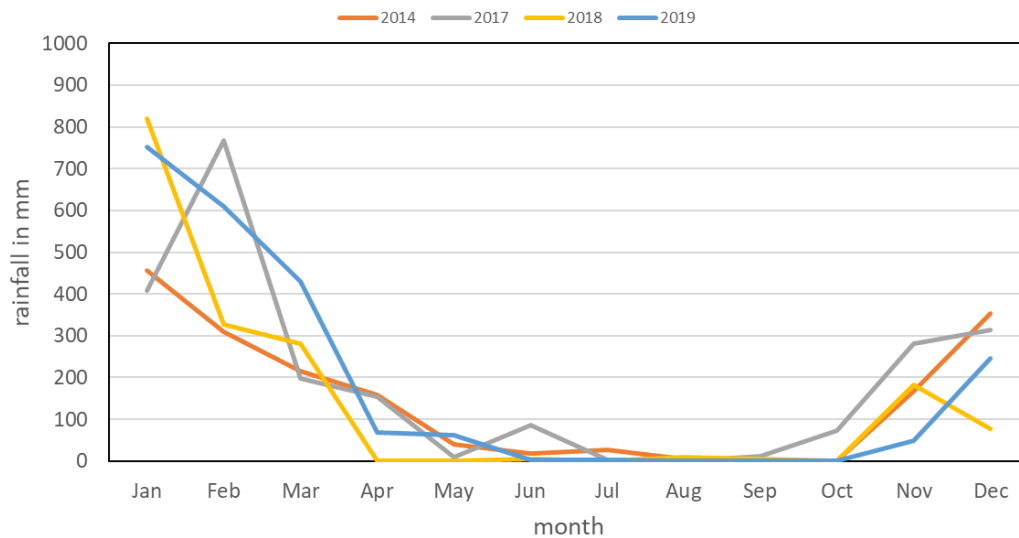
Figure 3. Rainfall Data for 2014, 2017, 2018, and 2019 (BPS East Lombok)

The eastern region of Lombok Island typically experiences its rainy season from November to April, as illustrated in Figure 4, which presents rainfall data over a four-year period. The production pattern of the hydropower plant generally aligns with these distinct wet and dry seasons. The wet season, characterized by higher rainfall, occurs between November and April, while the dry season, with lower precipitation, prevails from May to October.

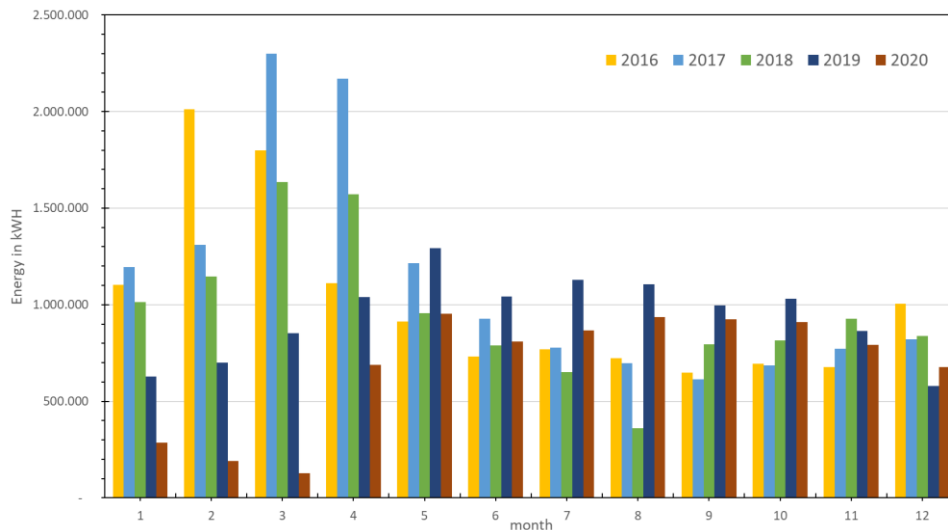
Figure 4. Electricity Production from 2016-2020

This pattern is reflected in the hydropower plant's production graph (Figure 4), where electricity generation peaks between February and March, coinciding with the high-rainfall period of the rainy season. During this period, the water flow to the turbines increases, resulting in greater energy production. Conversely, during the dry season, characterized by low rainfall, water discharge in the rivers and streams declines, leading to a decrease in the plant's electricity generation. This is evident in the graph, where electricity production reaches its lowest point in August and September.

Figure 4 illustrates that the hydropower plant's productivity in July and August 2018 was lower compared to previous years. This decline stemmed from a series of earthquakes in late July and August 2018, which induced downtime and consequently reduced productivity. Following the 2018 earthquake, the plant's production graph reveals a significant shift in the production pattern for 2019 and 2020. In contrast to the pre-earthquake pattern, where production consistently increased during the wet season, the post-earthquake period exhibits a decline in production during these wetter months. This is clearly evident in December 2018, where despite the onset of the rainy season, the hydropower plant experienced a decline in production compared to November. This phenomenon contrasts with the pre-earthquake pattern, in which December consistently exhibited higher production than November. To compare production changes during the rainy season before and after the earthquake, Table 4 was created, with the average monthly pre-earthquake production calculated as the mean production for the respective month from 2016, 2017, and 2018. The average pre-earthquake production data were then compared with the corresponding monthly production in 2019 and 2020, revealing the percentage decrease in production compared to the average pre-earthquake production.

The decline in electricity production during the rainy season at the Kokok Putih mini-hydro power plant exerts a dominant influence on the total annual output. This is evident in Figure 4, which illustrates that the rainy season constitutes the period of highest production, approaching the plant's maximum installed capacity. Consequently, this reduction in rainy season production significantly impact the company's revenue, potentially affect the survival business viability.
