THE INFLUENCE OF HOT POINT ON MTU CB CONDITION AT THE PGELI-GIUGUR 1 BAY LINE (PT. PLN PAYA GELI SUBSTATION)

Abstract

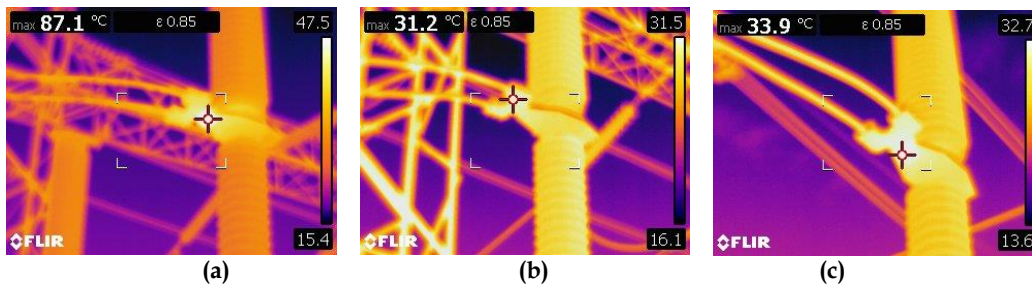
From Figure 5 it proves the phases R, S, T shooting of clamp material taken through a thermoving device at peak load. From the results of the thermovision reading, it was found that the highest temperature reached 87.1℃ occurred in Phase R. While the lowest temperature was 31.2℃ and it was read in Phase S. For Phase T, the temperature that was read through thermovision was 33.9℃. So, the comparison of temperature readings between the R phase and the S or T phase is very large, respectively 55.9oC and 53.2oC.

Figure 5. R, S, T phase clamps
(a). Lower pole clamp CT direction Phase R
(b). S-phase CT clamp the lower pole

To see the temperature difference between the clamp and the conductor, it is shown in table 3. The difference calculation is carried out using equation 1. The calculation results show that the temperature difference in Phase R produces the highest difference, namely 96.83oC and the lowest in Phase S, which is 2.69oC. The object being examined is CB/9.2 Downward Pole in the CT direction.

Object	Phase	Temperature difference between clamps and conductors ΔT (℃)
1	**CB/**9.2 Downward Pole CT	R	96,83℃
		S	2,69℃
		T	9,95℃

NO	Object		Temperature difference between clamps and conductors (ΔT)	Condition	Follow-up recommendations
1	**CB/**9.2 Downward Pole CT	R	96,83℃	5	Emergency Conditions
		S	2,69℃	1	Good condition
		T	9,95℃	2	Check during Maintenance

From the results of the analysis in the previous section it was found that with a high temperature difference between the clamp and the conductor which exceeds 70℃ from the NETA MTS 1977 standard, serious attention is needed. It is because to avoid the possibility of a short circuit.

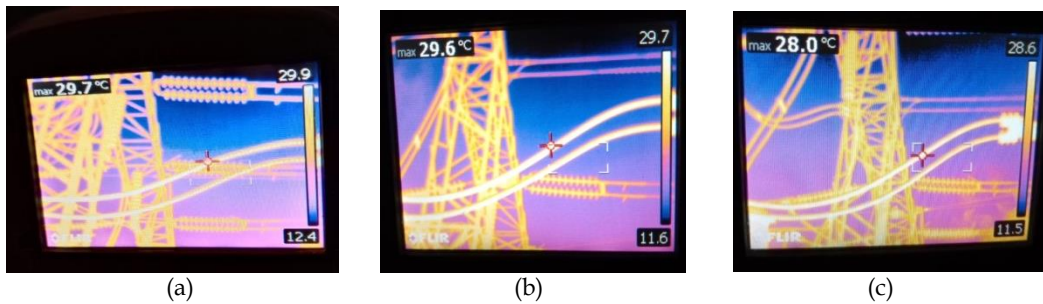
Meanwhile, from Figure 6 when shooting the conductor at peak load with FIIR E06 equipment, it shows different temperature values. From the results of temperature shooting on the R, S and T phase conductors, it is shown that the highest temperature is 29.7℃ in the R phase and the lowest temperature is 28.0℃ in the T phase while in the S phase it reaches 29.6℃. Hence, the difference in temperature readings on the conductors of each phase is very little, more or less 1.7oC.

(c). Lower pole clamp CT direction Phase T

Figure 6. Thermovision of R, S, T phase conductors
(a). Down pole conductor CT direction Phase R
(b). S-phase CT down pole conductor
(c). Conductor down pole CT direction Phase T
