Root Cause Analysis of Electrical Faults in Industry & other Facility

Abstract

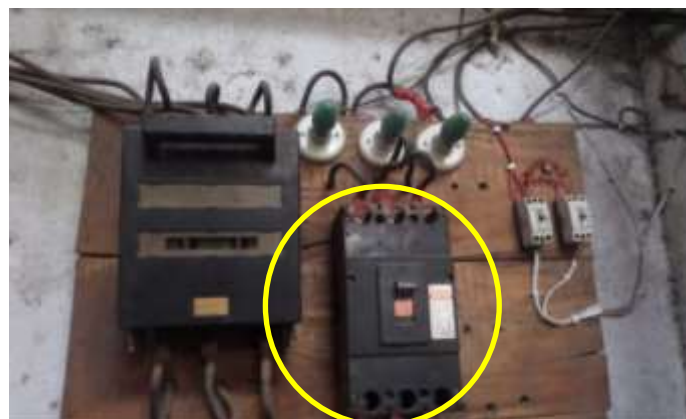
The breakers may have an actual rating of 600 volts AC (alternating current) (VAC) or less but are labeled as 1,000 VAC and may contain incorrect parts that can cause the breaker to malfunction. The hazardous condition may affect circuit breakers of any size and capacity. The circuit breakers may appear new, but a third-party rebuilder changed them from the manufacturer's original design. The third-party rebuilder reproduced and affixed a product label to the front of the breakers to make the circuit breakers look new and legitimate to their new duplicate capacity. These covers do not meet manufacturer specifications; the breakers may lack safety features and specifications, and possible threats such as phase-to-phase fault protection or proper grounding, circuit overload, fires, and power surges. In addition, the label used in front of the covers labeled 200A TP MCCB may be a 400A TP MCCB originally or less in rating, as shown in Figure 2.

Figure 2. Snapshot taken during factory visit (Breaker capacity unknown due to altered label)

Also, there is a high chance that short circuit protection will be compromised due to not tripping during an overload. Typical failures of circuit breaker include spring failure, loose component, jammed cores & operating mechanism faults (Chen et al., 2023).

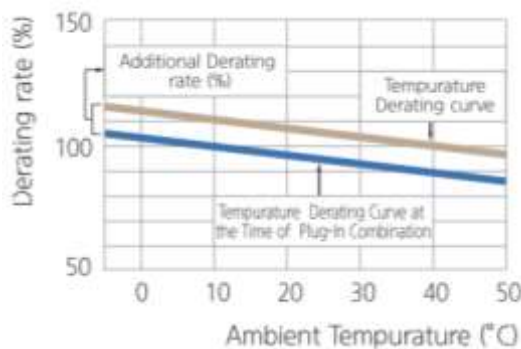
In (Rated Current): Circuit breaker's rating at about ambient temperature 40 °C

Ir (Real Current): Circuit breaker's rating at about ambient temperature

$$I_r = \text{Correction ratio (\%)} \times I_n$$

Figure 3. Sourced from Hyundai circuit breaker technical specification brochure

Various brand circuit breakers were manufactured with a variety of ambient temperatures. The industry does not practice circuit breaker adjustment according to load and ambient temperature. For instance, an overcurrent characteristic of MCCB has been set to the ambient temperature of 40 degrees Celsius in Hyundai circuit breakers. The overcurrent features can be changed if the ambient temperature (40 degrees Celsius) is less or more (Hyundai Electric), (Aronstein, 2022).

If the ambient temperature is less than 40 degrees Celsius, to ensure that the circuit breaker's overcurrent meets the derating curve [Figure: 2] at the given ambient temperature, the real current (Ir) should be adjusted as it can pass more than the rated current.

On the other side, if the ambient temperature is more than 40 degrees Celsius, thermal damage to the insulating material occurs inside the MCCB, causing the breaker to trip at an early stage. When applying ambient temperatures higher than 40 degrees Celsius, the circuit breaker must adjust [Table: 1] the rated current as per manufacturer guidelines more (Hyundai Electric), (Aronstein, 2022).

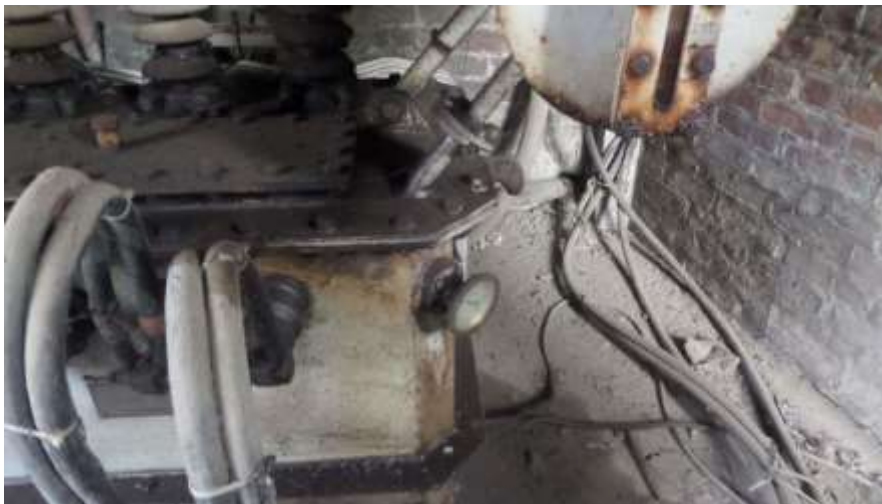
There are several reasons why a transformer may experience oil leakage. Age and wear are primary factors, as transformers deteriorate over time due to prolonged use and environmental conditions. Mechanical failures, such as a loose cover, broken tank, faulty gasket, or cracked insulation, can lead to oil leakage (Gray, 2009). When the internal temperature of a transformer reaches 150–300 °C under abnormal conditions, the mineral oils produce hydrogen and methane gases via chemical decomposition (Harbawi & Mubaddel, 2020), which causes corona & arcing. At temperatures above 300 °C, ethylene is formed, which causes severe overheating, and above 700 °C, large amounts of hydrogen and ethylene are produced [12]. The gases containing both the elements carbon (C) and hydrogen (H₂) are called hydrocarbons and are combustible. It has been reported that 70% to 80% of all transformer failures are due to internal winding insulation failure (Gajić et al., 2005).

Figure 6. Snapshot taken during factory visit (Oil leaking in an old transformer)

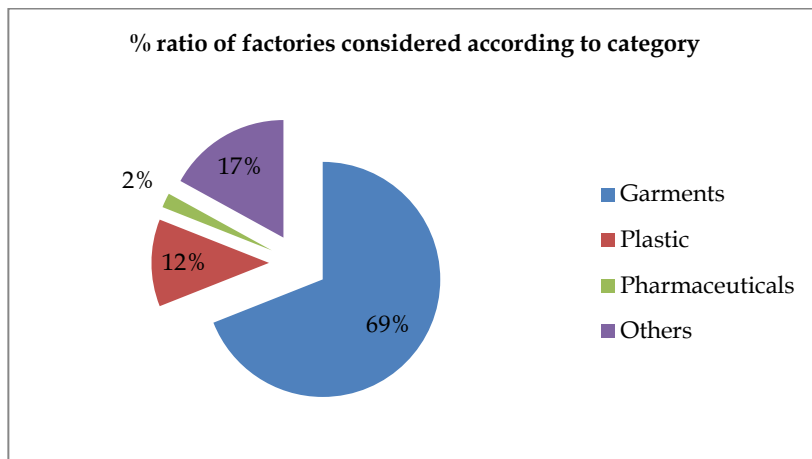
As a part of the data analysis, 120 factories of different production variants were considered. Field visits for data acquisition and previous safety assessment reports (Accord & DIFE factory inspection report) were studied for factories, including plastic product manufacturing, garments, pharmaceuticals, and others [Figure: 8].

Figure 8. Type of factory considered for field visit and assessment report

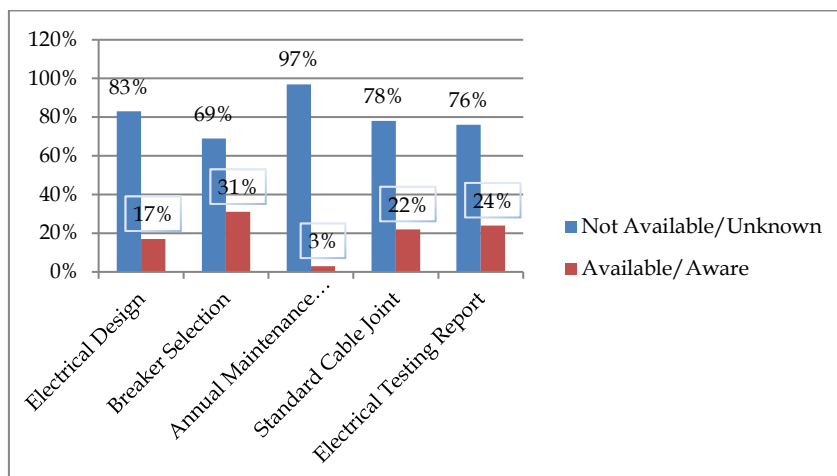
Lists of findings were used to collect initial data considering the research objective. Major electrical findings of industries include electrical design as per guidelines, circuit breaker selection compared to wire and load capacity, periodic maintenance of substation & power distribution system, standard cable joint, equipment & electrical testing, etc. [Figure: 9].

Figure 9. Five major electrical findings considered for analysis
